Manhole Inspection Summary

Manhole # S19M__032MH

Insp Date: **2/27/09 9:00 AM**

Location Address: **2203 ASHTON-CHRISTIAN-ALLEY**

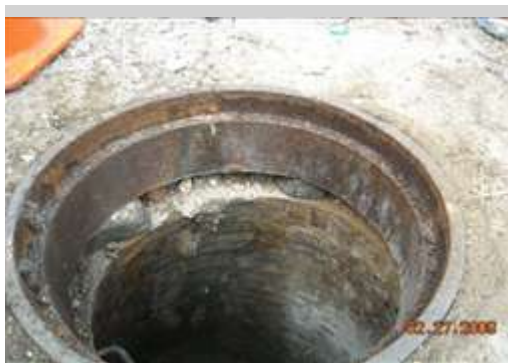
MISC.

Subject To Ponding: **Sheeting**

INFLOW EVIDENCE FROM SHEETING

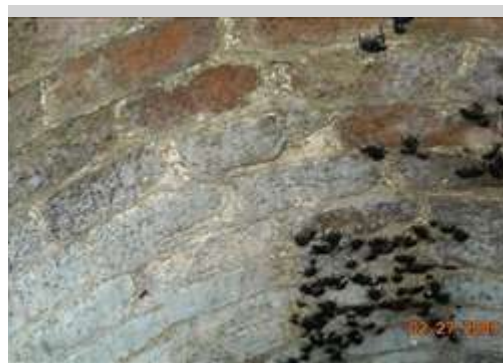
Defect 7

☒ **Cracked**

CRACKED CORBEL BRICKS

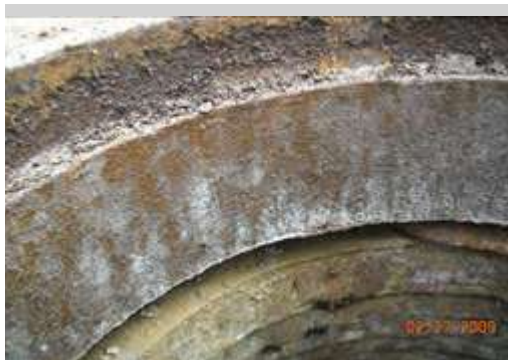
Defect 6

☒ **Leaks**

FRAME LEAKS

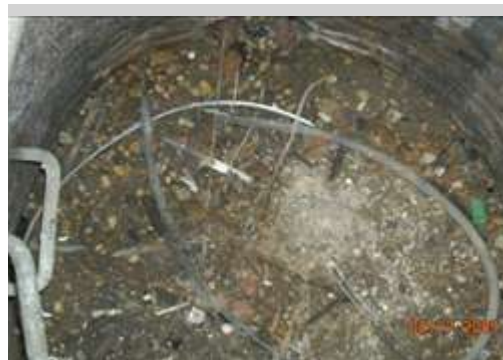
Defect 5

☒ **Debris**

DEBRIS IN TERMINAL CHANNEL

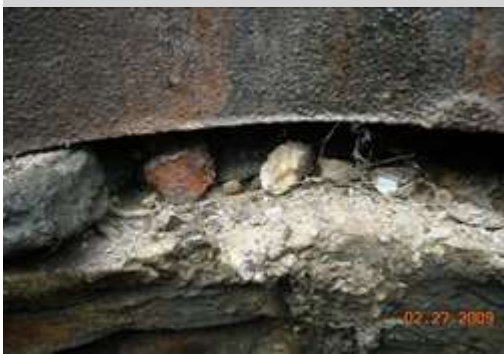
Defect 4

☒ **Deteriorated**

DETERIORATED CHIMNEY

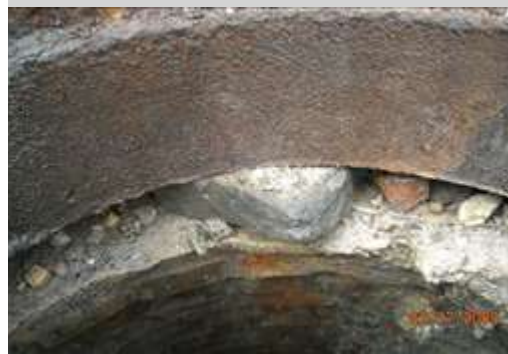
Defect 3

☒ **Loose Brick**

LOOSE CHIMNEY BRICK

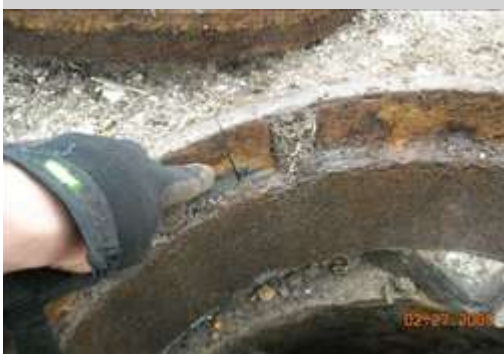
Defect 2

☒ **Cracked**

CRACKED FRAME

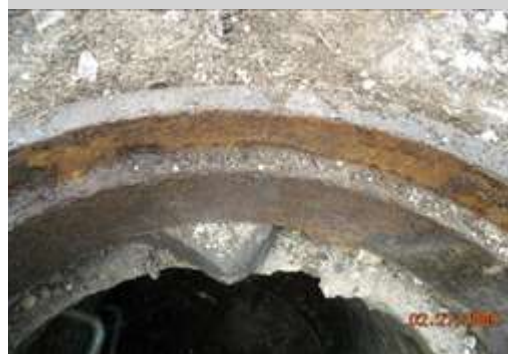
Defect 1

Offset: **2** (in.)

FRAME OFFSET

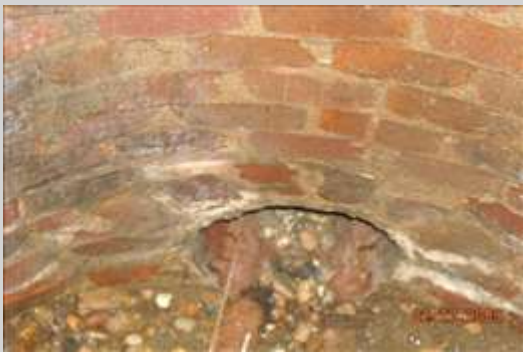
12 O'Clock Outflow

8 in. Circular Gravity Sewer
Pipe Out @ 12 O'Clock

Deposits: ☐ None ☒ **Mud** ☐ Sludge ☒ **Debris** ☐ Grease

Silt Depth: **1.5** (in.) Deposits Extent: **Light**
